## Trus<T>Lift Drive Nut Safety Bulletin

The following Safety Bulletin is to inform all Trus<T>Lift installers & owners of a critical safety check of the drive nuts that support the Trus<T>Lift platform. The following safety check must be performed annually on every Trus<T>Lift.

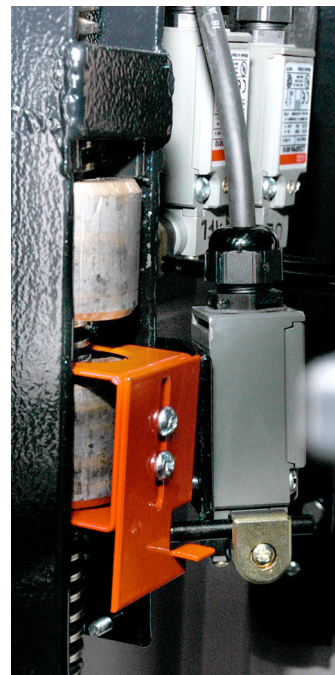
The top bronze drive nut is the main support that raises and lowers the platform. It is made from a low friction bronze bushing material that will wear over time. The lower nut is a safety back-up nut made from the same material intended to protect the platform from freefall should the main nut fail. It must not be used as a main drive nut.

- Bronze drive nuts should be spaced apart by  $\frac{3}{4}$ ".
- Both the drive nut and the back-up nut should be positioned in the channel as seen in the photo.

- The Lower drive nut includes a back up safety bracket (red plate as pictured).
- The back up safety bracket is included on all lifts manufactured after May 13/04 (serial # TS 13220 and up)
- *The back up safety bracket can be easily added to existing lifts manufactured prior to May 13/04.*

- The purpose of the safety back up plate is to indicate to the user when the main lifting nut has failed.
- If the main nut fails the lower back-up nut will move up  $\frac{3}{4}$ " resulting in the lower limit switch becoming activated by the safety plate. The lift will only operate in the up direction until two new drive nuts have been installed.
