## Stratus™ Product Bulletin Main Drive Screw Brake Key

Date: 18JUL2016

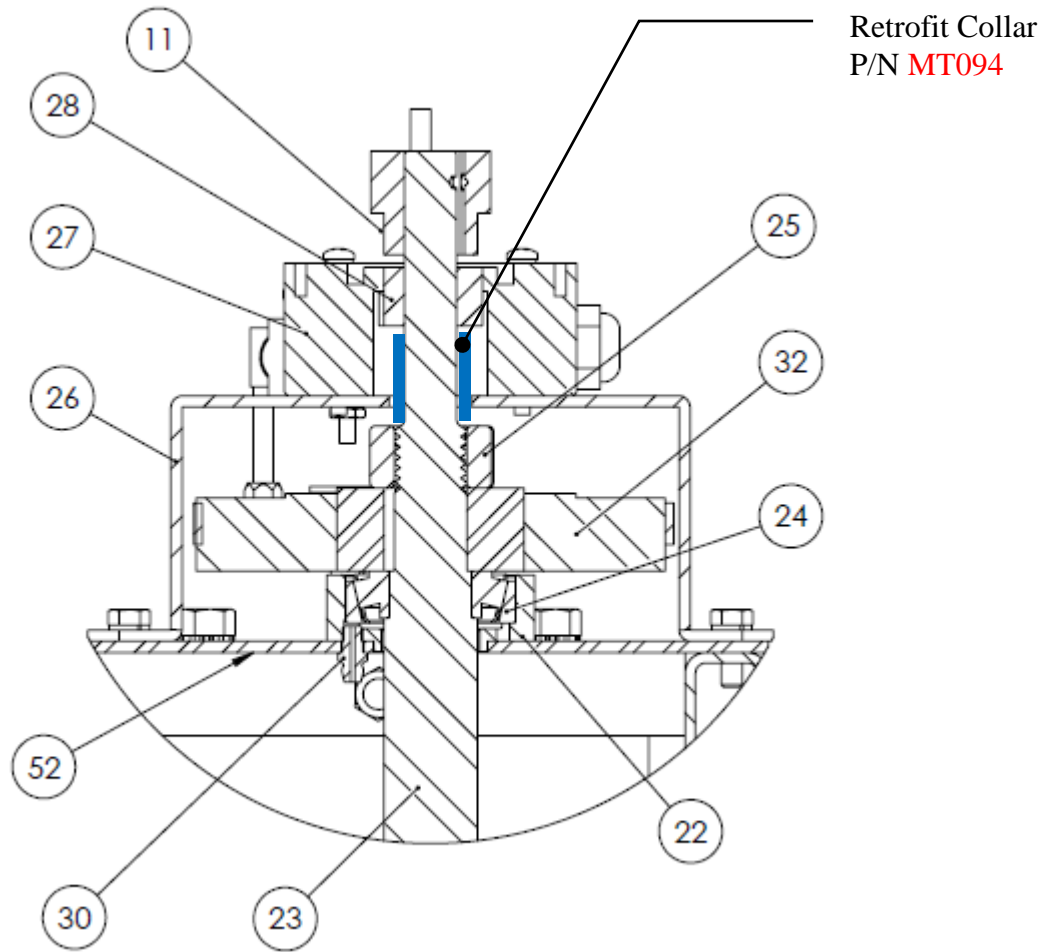
It has come to RAM's attention that for some Stratus™ products a condition can exist where the brake gear (item 28) that interfaces between the brake and the main drive screw coupler (item 23) can move in the downward direction if not secured properly with a set screw that interfaces with a drilled dimple on the drive screw coupler. (See image on next page for reference).

In the event that this occurs, the key between the gear and the coupler may come out and the brake will no longer function correctly and this could lead to unintended carriage movement in some load conditions.

RAM has remedied this for Stratus™ products going forward by changing the drive screw coupler profile such that a shoulder will keep the brake gear in place.

Although RAM considers the risk to be low for this issue RAM has prepared a solution for field retrofit that utilizes a simple collar to keep the brake gear from moving in the downward direction.

RAM recommends that you inspect for this issue as soon as possible and at the very least, during annual maintenance, plan to apply the retrofit collar if your elevator is in the affected serial number range.

RAM will provide the **parts (MT094 and MT095)** required to alter any lift that presents this issue at no charge. The procedure for installation will be sent with any parts issued.
